MTL TR 92-31

## TESTING AND ANALYSIS OF MODIFIED HMMWV FRONT LIFT PROVISIONS

CHRISTOPHER CAVALLARO, ROBERT B. DOOLEY,  
KRISTEN D. WEIGHT, and PAUL V. CAVALLARO  
MECHANICS AND STRUCTURES BRANCH

May 1992

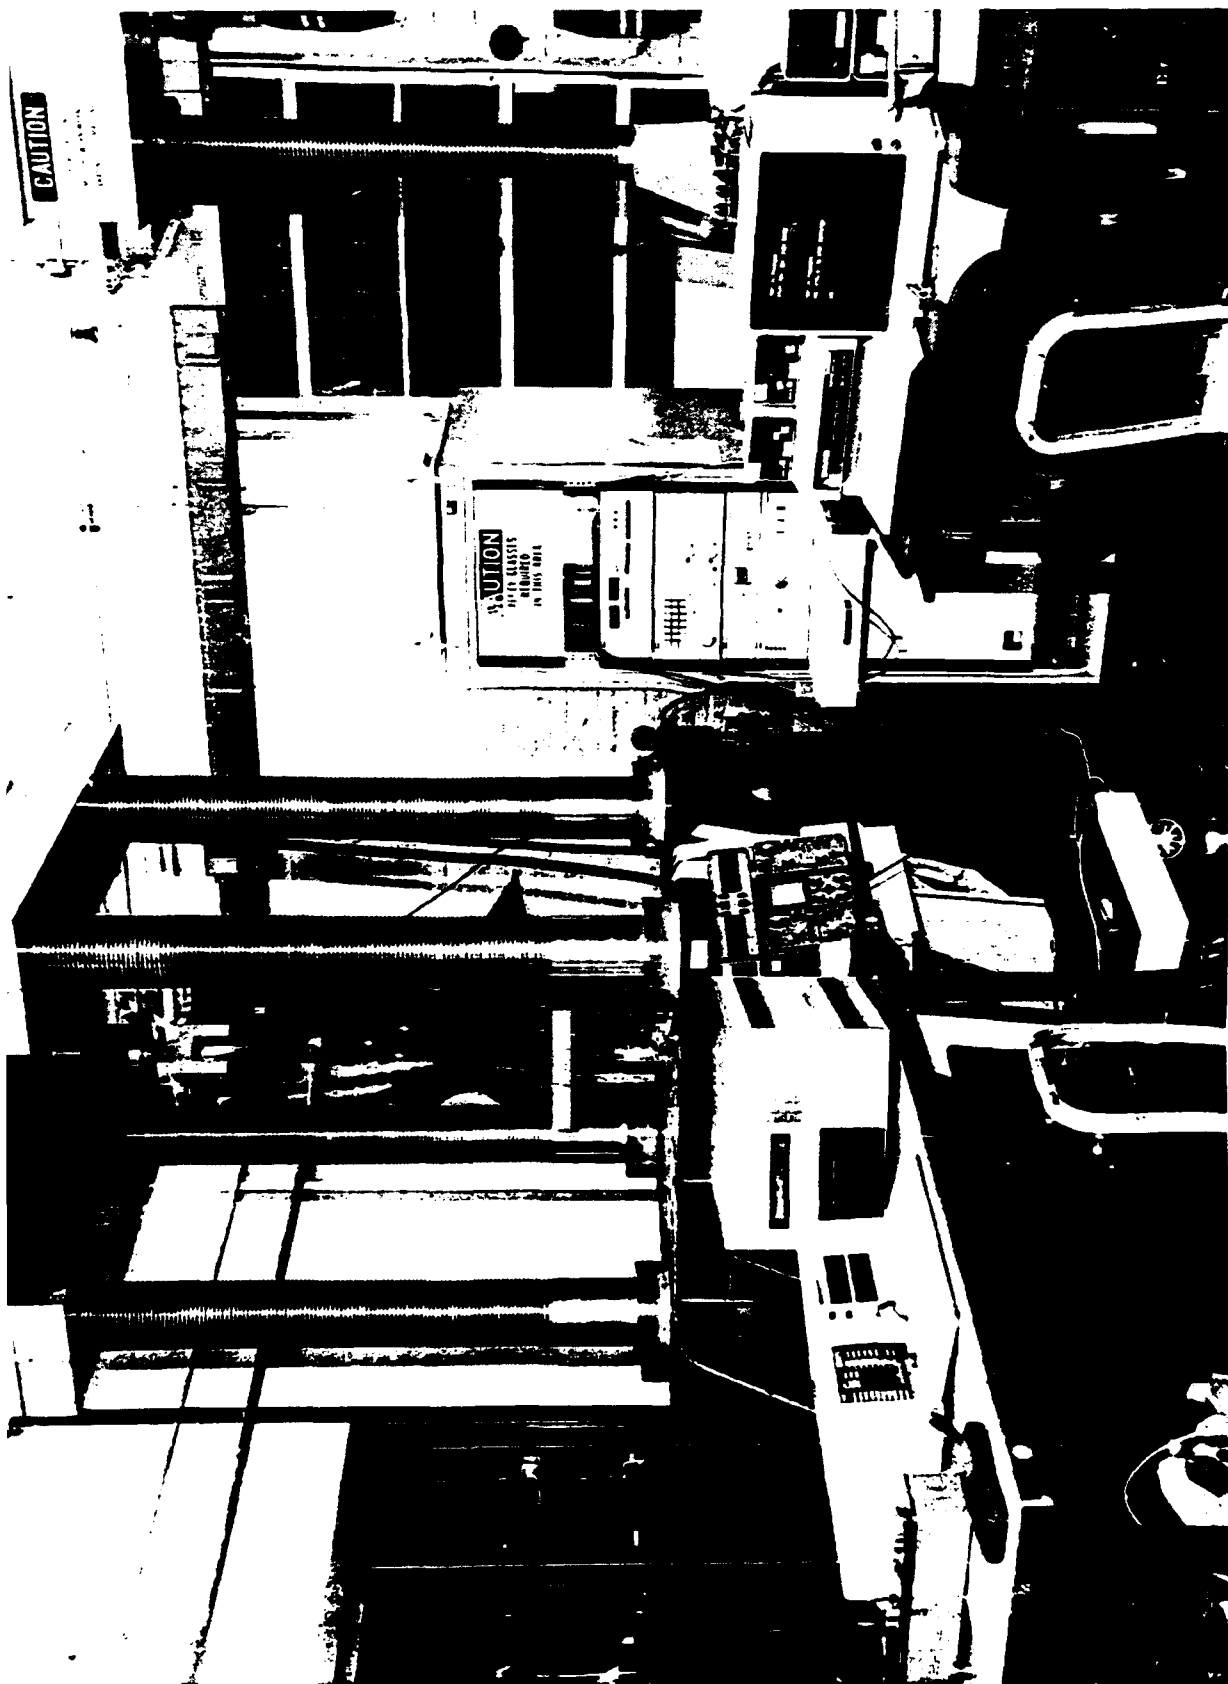
Figure 7. Ultimate pull test - machine and setup.

To assess the overall strength of the provision, an ultimate pull laboratory test was performed for each load configuration utilizing a new provision for each test (designated provisions A and B). These tests were performed in a 150,000 lb hydraulic tension/compression test machine (see Figure 7).

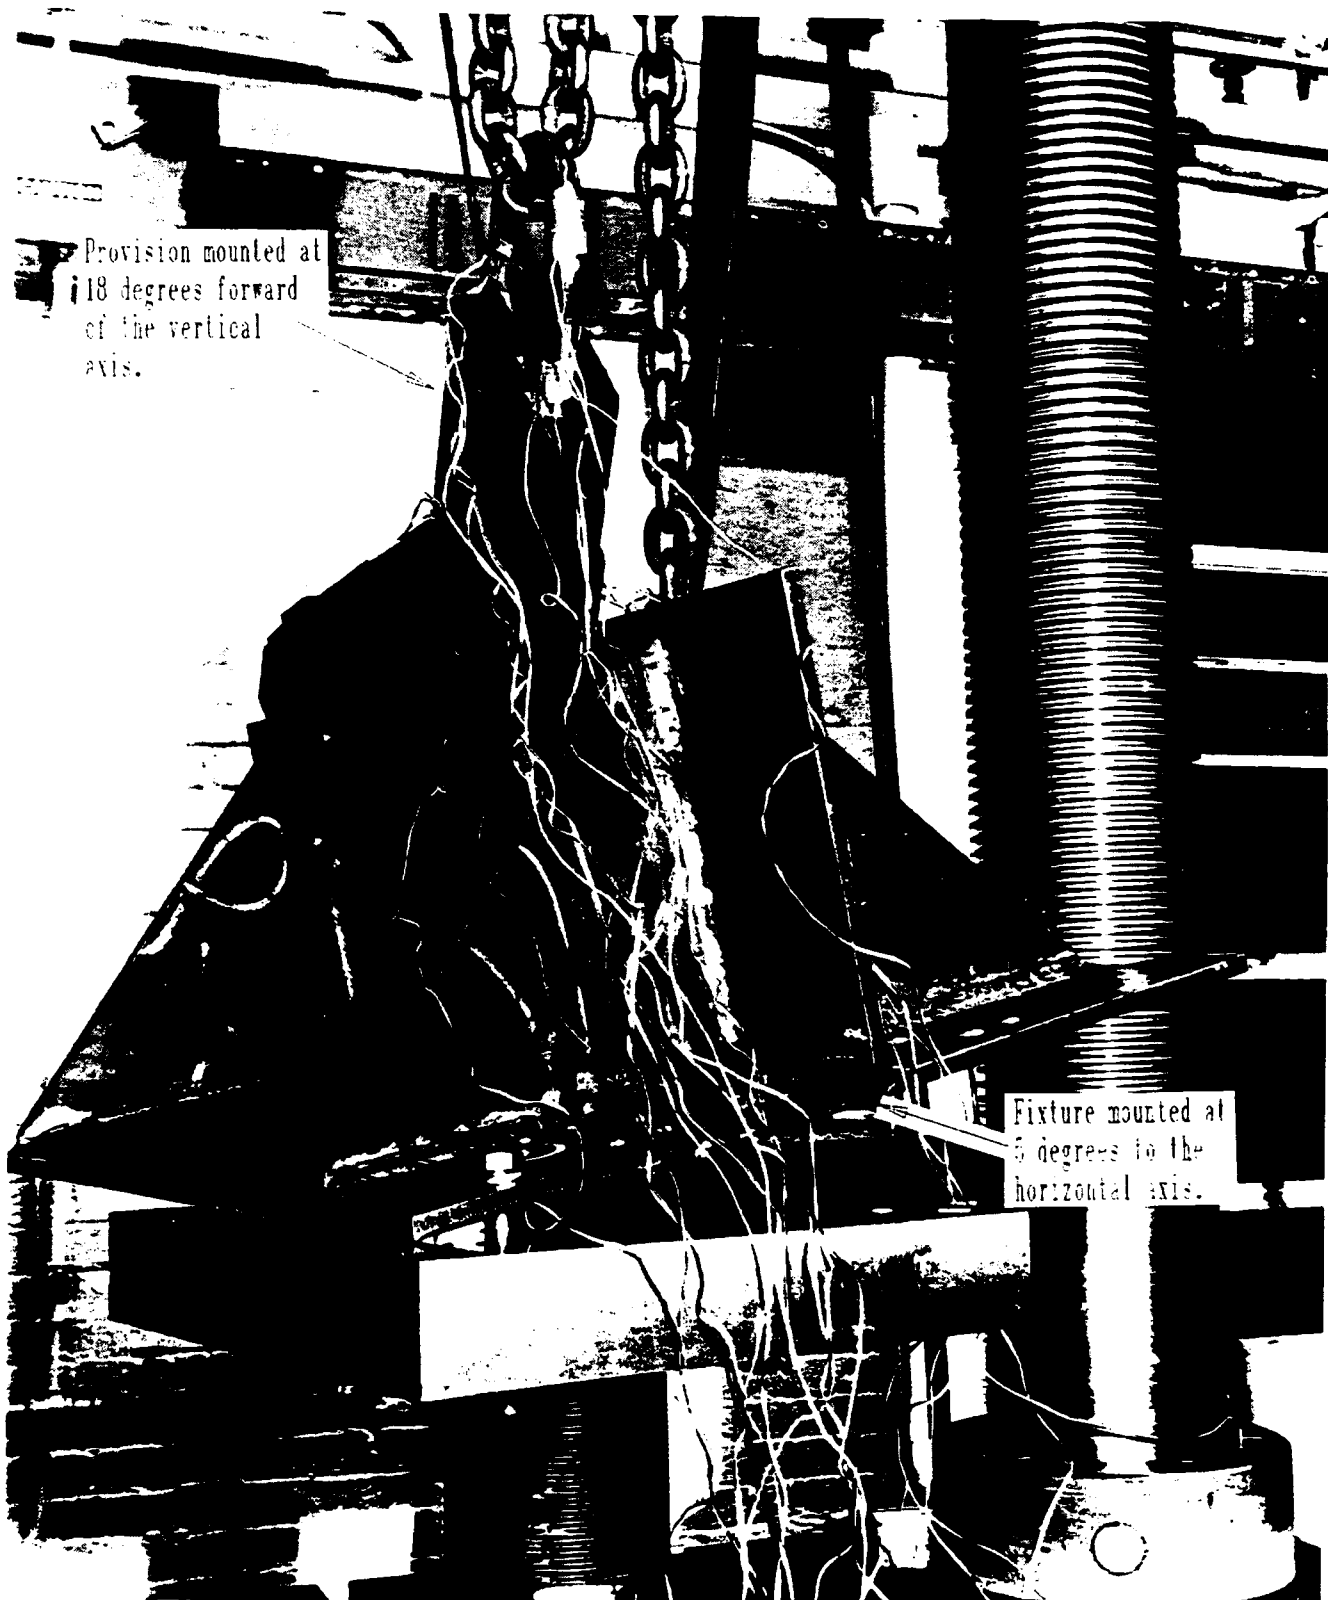
Figure 8. Fixture and provision installation for 9600 lb ultimate pull test.

The first ultimate pull test performed was the 9600 lb/30° configuration on provision A. Due to the test machine's load path and our desire to fully simulate the manner by which the provision is loaded on the HMMWV, the test fixture was installed at an angle of 5° with respect to horizontal and with a 3.25" offset from the line of loading. The provision was mounted on the fixture at an angle of 18° forward to the line of loading (see Figure 8). These angles and the offset assured that the out-of-plane load was applied at the same angles as those of a provision mounted on a HMMWV.
